Examining phosphorus contributions from alluvial soils – a comparison of three Vermont, U.S.A. River corridors

Caroline Alves^A and Don Ross^B

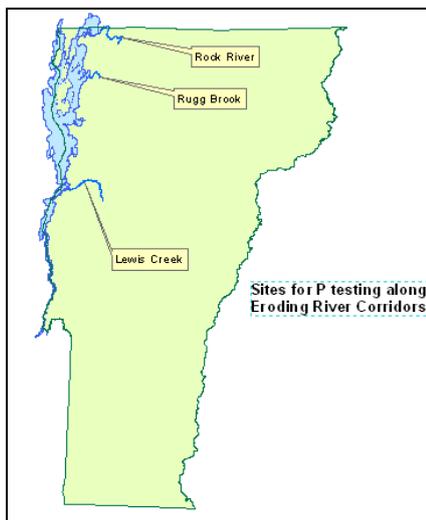
Figure 1. Three Vermont River Corridors along which soil pedon samples were taken.

A total of 28 sites have been sampled to a depth of over 120 cm, in most cases. Three river corridors which are spread out geographically across northern Vermont were studied (Figure 1). The majority of samples are from so-called "benchmark soils" which are distributed widely throughout numerous physiographic regions of the northeastern United States. Efforts were made to take samples in areas that were in close proximity to sloughing banks. Many Vermont streams and rivers are incising downward into the streambed, resulting in floodplains that no longer receive sediment when the river is at flood stage (Figure 5). The increased velocity of floodwaters, trapped in the channel, further exacerbates the problem of eroding river banks; thus there are extensive areas from which to take samples. The goal was to find areas that have been largely unmanaged, without fertilizer inputs, in order to gain an understanding of background P levels in relatively unaltered soils. The riparian corridor sampling project has been a joint undertaking of the University of Vermont and USDA-NRCS. Parallel efforts to develop a bank stability / toe erosion model by the USDA Agricultural Research Service, in collaboration with the Vermont Department of Environmental Conservation, will also benefit from the expanding database of P levels in alluvial soils that is being developed from this study. Pedon characterization studies previously conducted over the past decades by NRCS in Vermont did not include data for phosphorus. The Agricultural Testing Laboratory at the University of Vermont has done

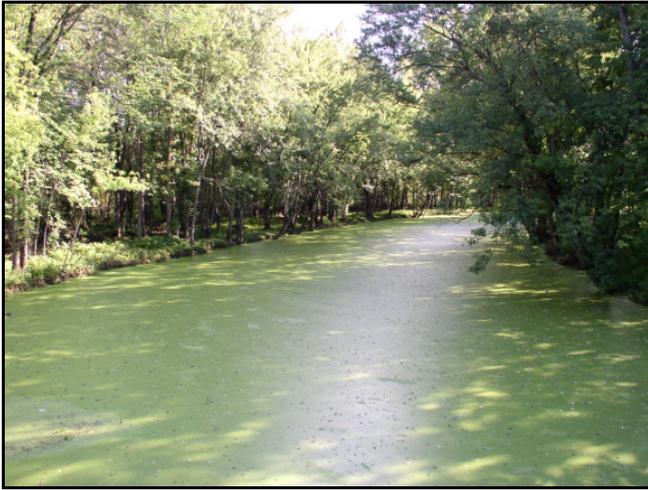
Figure 4. Near the mouth of the Rock River – evidencing severe water quality issues.

The Rock River has the worst water quality of any tributary of Lake Champlain (Figure 4). A comparison of soluble P levels among all three river corridors, shows the Rock River samples to have a higher proportion of measurable readings (Figure 3). The water soluble phosphorus is the fraction extracted by distilled water in laboratory tests. It represents an attempt to approximate the P concentration in the soil solution, i.e. the mobile P (Burt 2004). The highest reading in the Rock River samples is from an A horizon that had high organic matter content. While, the highest reading of all the samples was from a Cd horizon of lacustrine origin. Samples from Lewis Creek had few readings that registered above trace amounts, except in the clay soils dominated portion of the corridor.

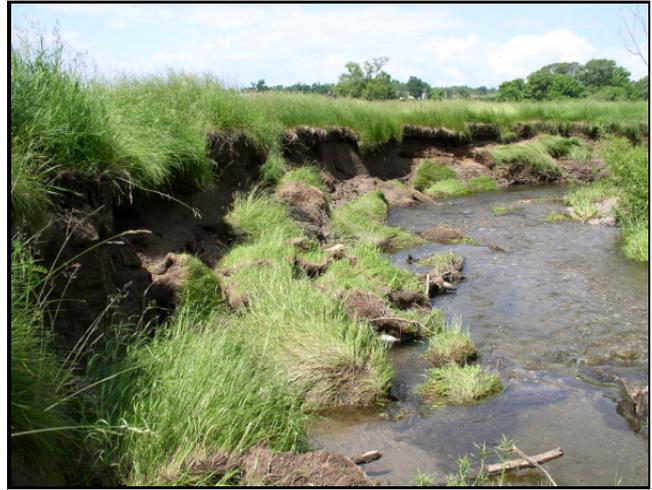
Figure 5. Bank erosion along Rugg Brook – within the past 5 years the streambed has incised 2.5 meters.
