Gully erosion stabilization in a highly erodible Kandiustalf soil

Maria Teresa Vilela Nogueira Abdo^A, Sidney Rosa Vieira^B, Antônio Lúcio Mello Martins^C and Luis Cláudio Patterno Silveira^D

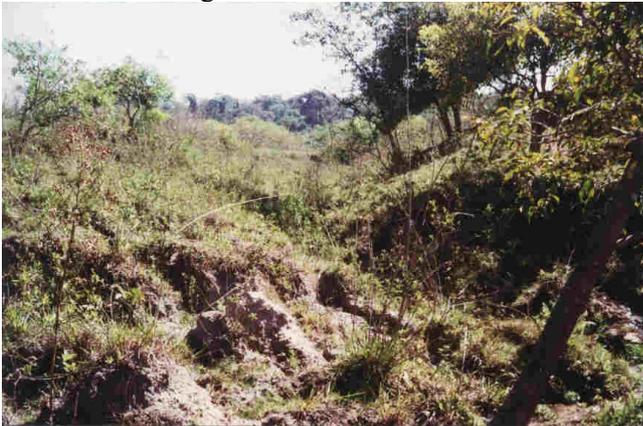
Figure 1. General gully view before the work.

Soil and sediment flowing down the eroded gully has plugged the lower drainage channel.

The erosive process happened in a severely gully-eroded landscape with a Kandiuistalf soil, primarily clay eutrophic sandy, which are well drained and have an average slope from 2 to 10%. This slope and a sandy A horizon and a textural gradient to the B horizon make these soils very susceptible to water erosion (Lepsh and Valadares 1976). This susceptibility to erosion was aggravated by inadequate management of the area, which for decades had been used as pasture with no soil conservation practices. The coffee crop planted down hill, without enough conservation measures and with a very low production was soon transformed into pasture in this area that was already degraded. Excess runoff increased deeply the cattle tracks towards the water bed, in the lower part of the area. As a result an erosion of considerable proportions was formed as it can be seen in Figure 1.

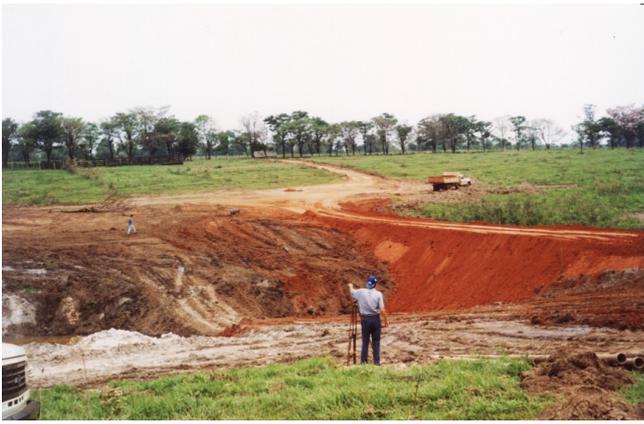
Figure 2. Pond construction.

In order to control the rate of water flow through the gully, four ponds (gully dams) were constructed aligned perpendicularly to the erosion direction. In addition, the distance between dam walls was calculated to allow water to back up almost reaching the end of the previous dam (except the first one). This way would be possible that the water from a pond pour into the next pond, and so forth. This way the water could be conducted from the beginning to the end of the erosion without carrying soil. The positions of the ponds were marked out and the vegetation present on those positions were removed so that the central part of the ponds where the soil had to be the base of the dams could be strongly compacted, generating a strong intern wall, such that the water could not pass through inside or down the pond. Within this marked central area, from four to six meters wide, a technique called "cut off" was used. This consisted of removing soil material, until a firm soil was reached, preferentially a clayier soil than the original one. Once the central part of each dam was completed, soil to fill the "cut off" was brought from a different area, from a B horizon (so, clay soil), placed in 20-30cm lays and then compacted manually or using a pressure equipment pulled by a tractor. When a layer was fully compressed, new layer was poured, and so on until the desired height was reached according to the calculations. Water was applied to raise the B horizon material to a moisture content suitable for maximum compaction with a compressing process. Figure 2 shows a pond finished.

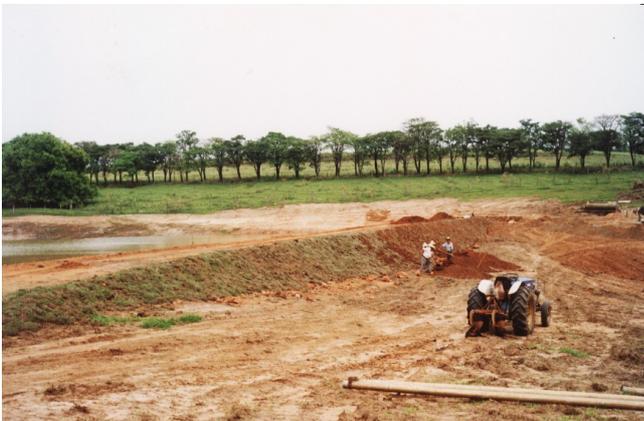
Figure 3. Grass planting in the dams.

After the construction, the ponds sides were covered with grass. The whole area that was cleaned initially was covered with grass to avoid erosion around the ponds, which could compromise the investments done as well all the work done (Figure 3). To enable the free running of the flow of excess water from rain, concrete drain canals were constructed to minimize dam wall erosion in storm conditions.

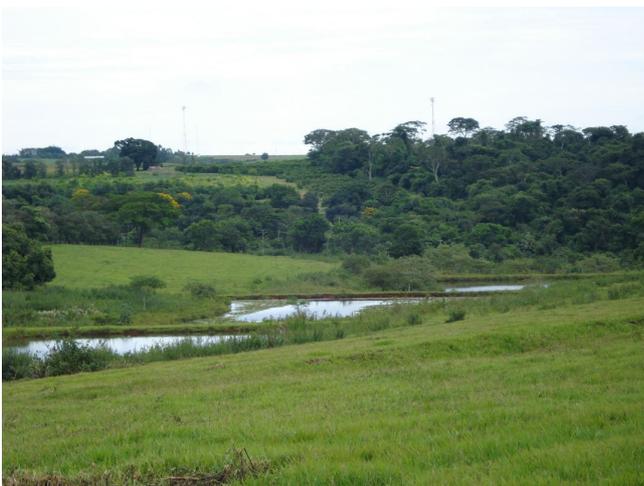
Figure 4. Present view of the dams.

The gully erosion has been stabilized in the highly erosive Kandiuistalf soil by avoiding channel flow and controlling the velocity of surface run-off. Actually, as it has been ten years from the beginning of the project, it can be considered that the stabilization/rehabilitation process offers farmers a solution to the erosion problem, minimizing their loss of soil and returning the land to a productive state (Figure 4). In the example presented, the gully which was formed by previous unsustainable agriculture practices was stabilized avoiding pollution and forest destruction that is just above the eroded area, ensuring the area
